2008 Annual Inspection and Radiological Survey Results for the Piqua, Ohio, Decommissioned Reactor Site

The former Piqua Nuclear Power Facility (PNPF), a decommissioned nuclear power demonstration facility, was inspected on April 24, 2008. The site, located on the east bank of the Great Miami River in Piqua, Ohio, is in good physical condition. There is no requirement for a follow-up inspection.

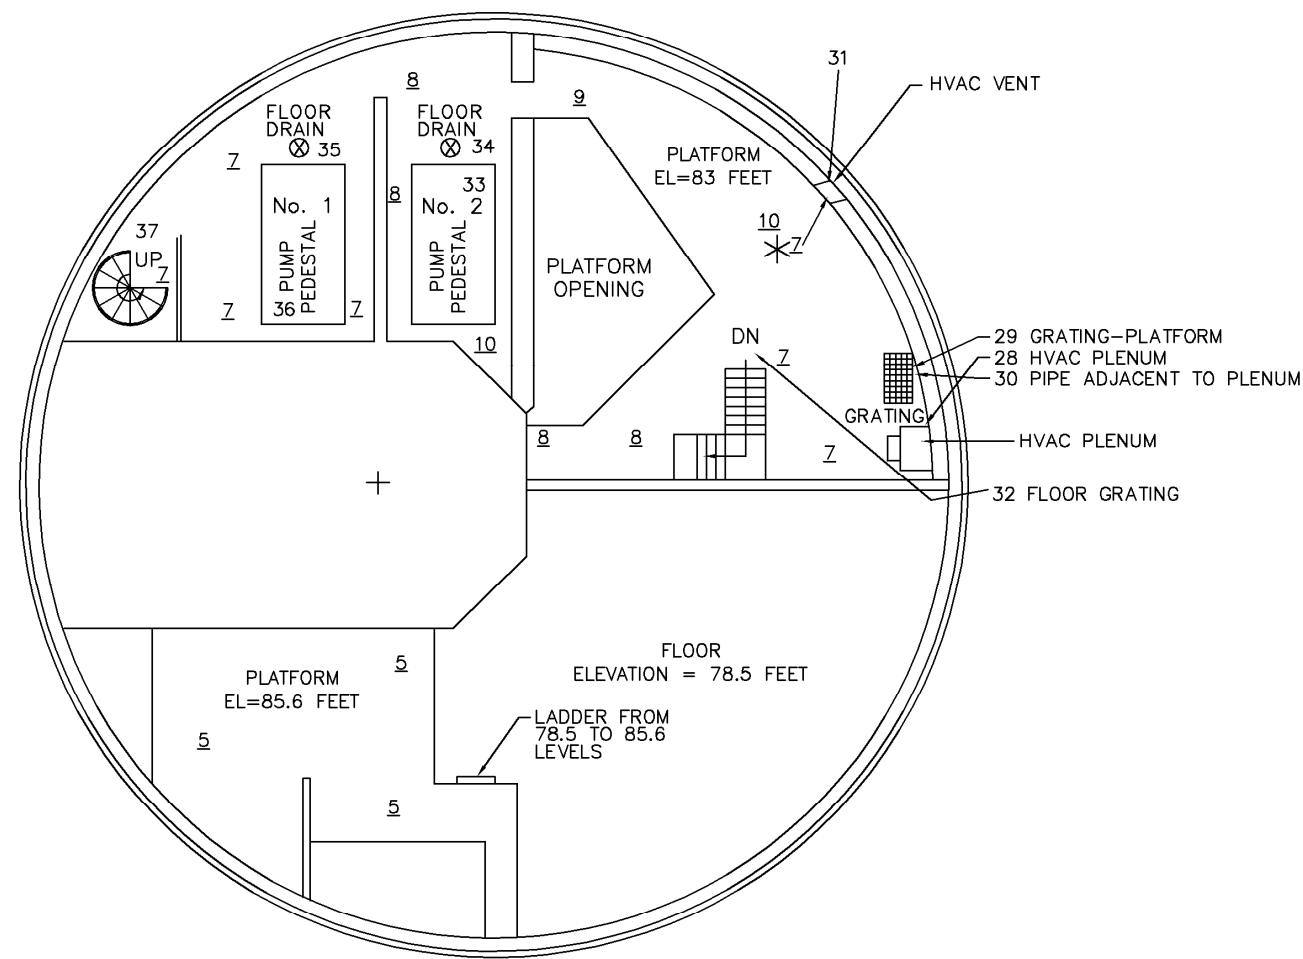
PLAN - 83 FOOT LEVEL

NOTE: ALL 2008 GAMMA CONTACT AND
GENERAL AREA READINGS
WERE \leq BKGD ON THE 83-FOOT LEVEL.
